# Lac Courte Oreilles & Little Lac Courte Oreilles Septic Survey

Summer 2013

Sawyer County Intern Craig Dantoin

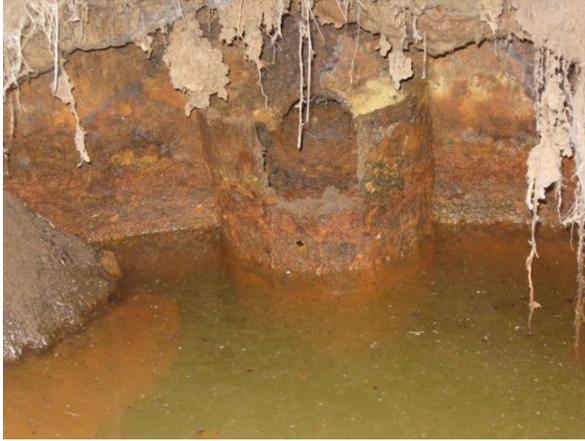
Large hole rusted through outlet baffle on steel tank

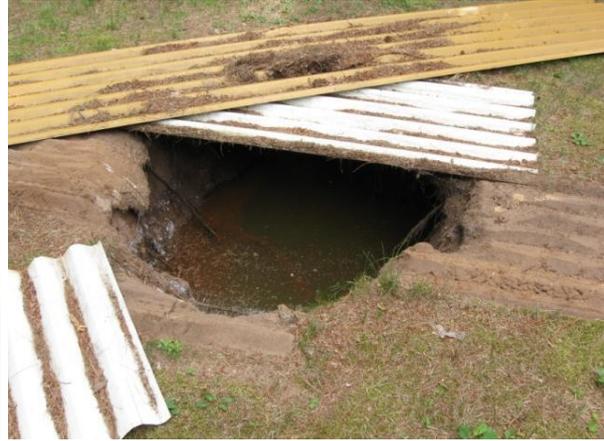
Top of steel tank collapsed (covered by neighbor so dogs would not fall in)
