# Lac Courte Oreilles & Little Lac Courte Oreilles Septic Survey

Summer 2013

Sawyer County Intern Craig Dantoin

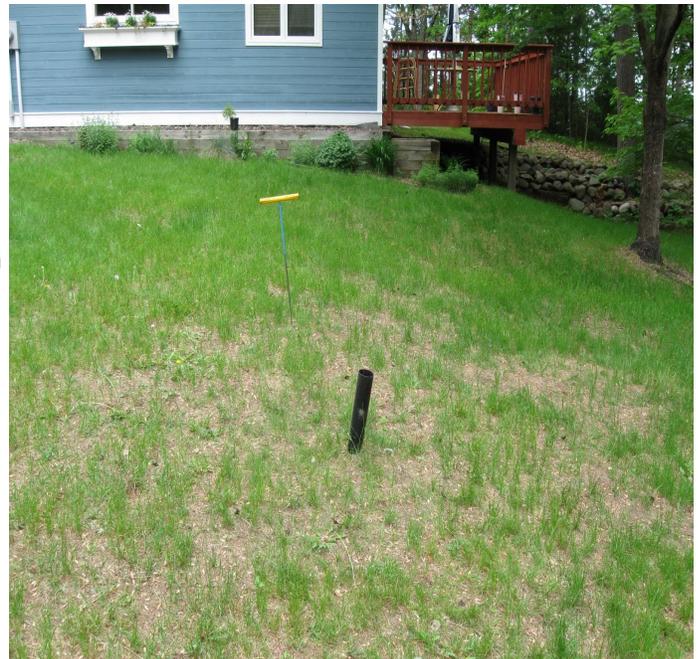
- Applying pressure to tank with tile probe or “T-Probe”, shown below, to ensure integrity of tank (steel tanks).
6. Doing walk around site/house to inspect for “graywater” discharge of domestic household waste (especially from washers and sinks), prominent in low lying areas with holding tanks. (Particularly with owners are worried about contributions to a tank that has to be pumped when full)
